The Impact of Visual Anomalies on the Barrier Properties of Metallized Biaxially Oriented Polypropylene Film

A.M. Comer, Applied Extrusion Technologies, Inc., Covington, VA

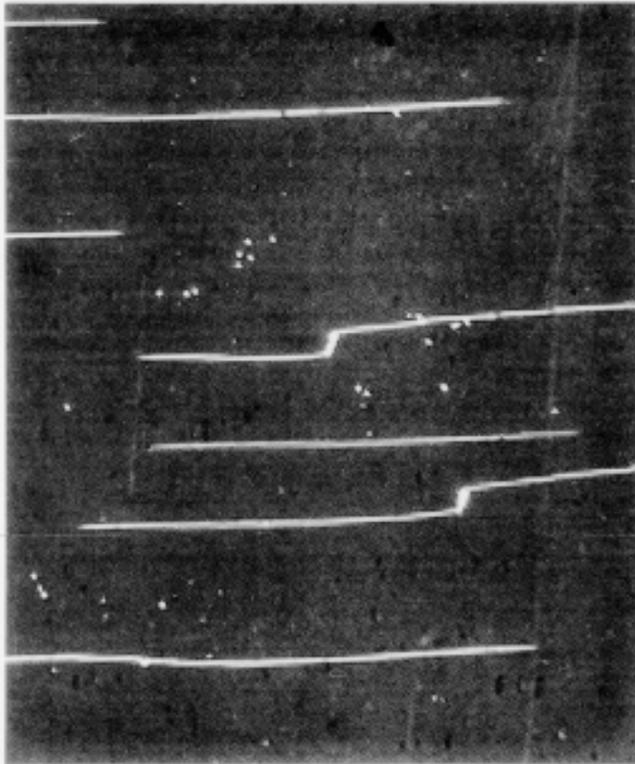
Figure 1 is a micrograph of a metallized OPP film which was heavily crazed during lamination. This film utilizes our new proprietary surface technology. OTR and WVTR data are given in Table II for this metallized OPP film before and after crazing.

Figure 1: Magnification 67x 250 μm
Micrograph of Metallized OPP Film

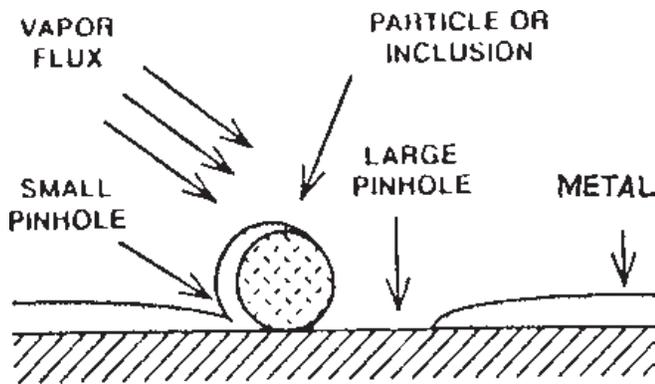
Pinholes arise from surface roughness under a limited range of vapor deposition angles, or from the dislodging of coated, particulate, surface contaminates. For this discussion, pinholes are defined as an area in which no metal deposition appears to have occurred. Figure 2 shows one possible way a pinhole can result from surface contamination. In this picture, a shadow is formed where a particle shields the surface from metal vapor deposition.

Figure 2: Pinhole From Surface Contamination

This type of visual surface anomaly, especially if large, seems to affect barrier no matter what type of metal bonding surface is chosen. This is not surprising if no metal is deposited in the shadow. However, it appears that not all pinholes are formed this way because we have observed samples with a large number of visual pinholes that still exhibit good barrier. These good barrier results suggest that something, perhaps aluminum oxide, is present in the pinhole areas.

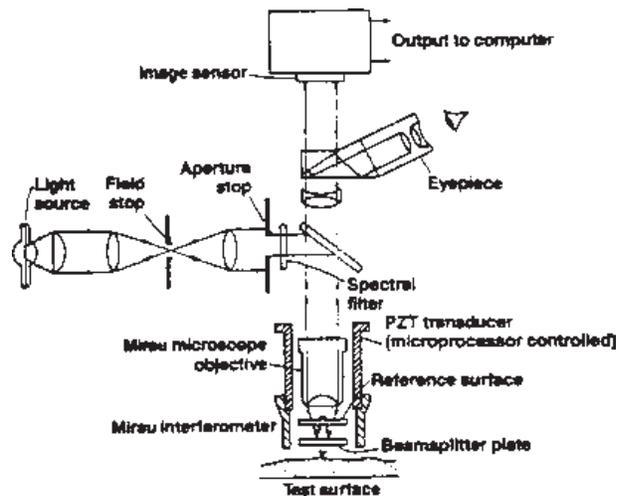
Two methods were used to characterize the film surface, optical metrology and surface microscopy. One method of metrology is a TOPO system. This system, a modified microscope used by WYCO Corporation in Tucson, Arizona, determines surface profiles, surface roughness, and statistical measures of surface roughness. A layout of the TOPO optical profiler is given in Figure 7 [2].

Figure 7: Optical Layout of the TOPO Optical Profiler

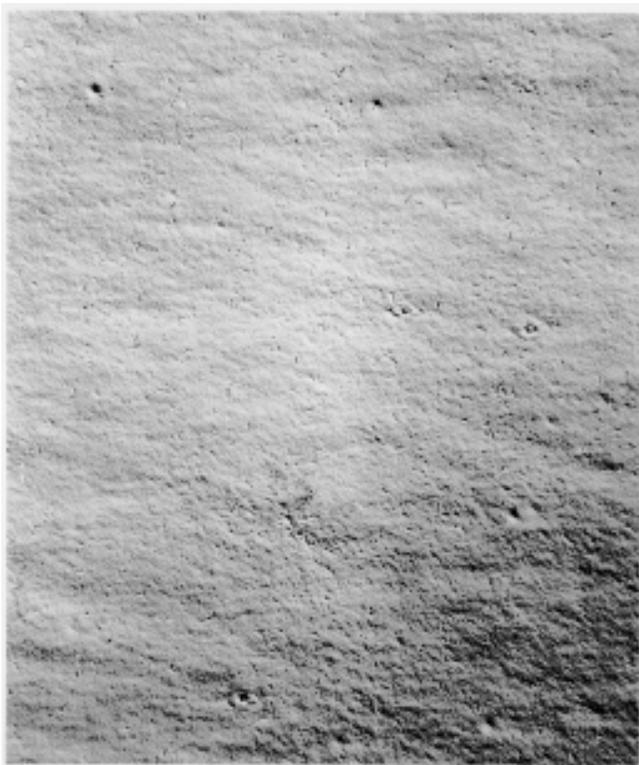
Figure 3: Magnification 100x 100 μm
Film Surface "A" - Unmetallized

Two different metallized film surfaces were characterized by surface microscopy and metrology. Surface "A" (a common metallized OPP) had an OTR of 93 cc/m²/day/atm while surface "B" (our metallized OPP with a proprietary surface technology) had an OTR of 15.5 cc/m²/day/atm. Both film surfaces were metallized under similar conditions. Micrographs of the film and metallized surfaces are presented in Figures 3, 4, 5, and 6.

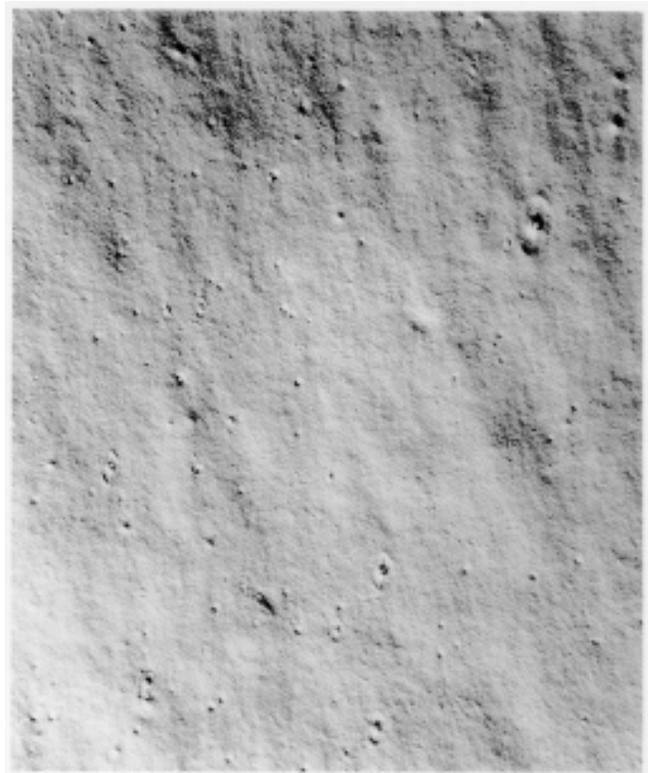
Figure 5: Magnification 100x 100 μm
Film Surface "A" - Metallized

Surface "B" in Figure 6 appears smoother than surface "A" in Figure 5. The RMS (Root Mean Square) data in Table V, shows that both surfaces are approximately the same surface roughness. However, the standard deviation of surface "B" roughness, with or without metal deposition, is approximately one half that of surface "A".

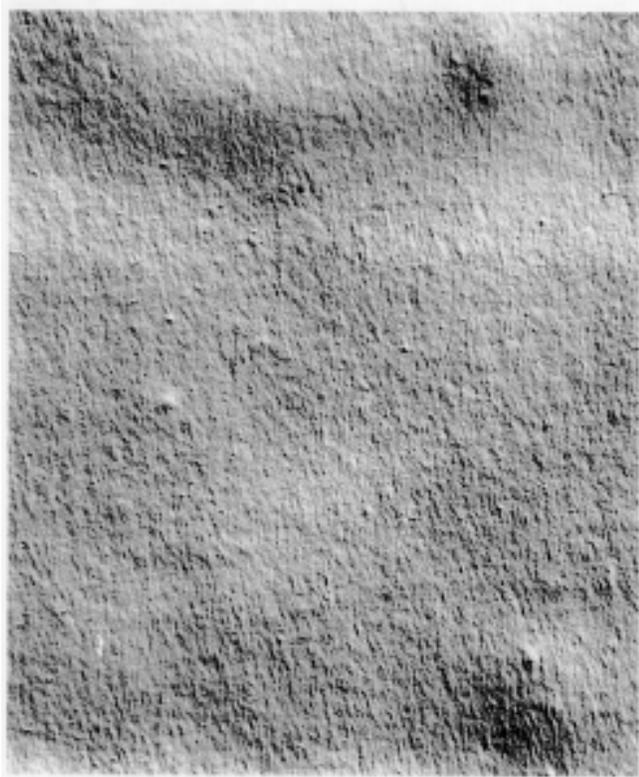
Figure 4: Magnification 100x 100 μm
Film Surface "B" - Unmetallized

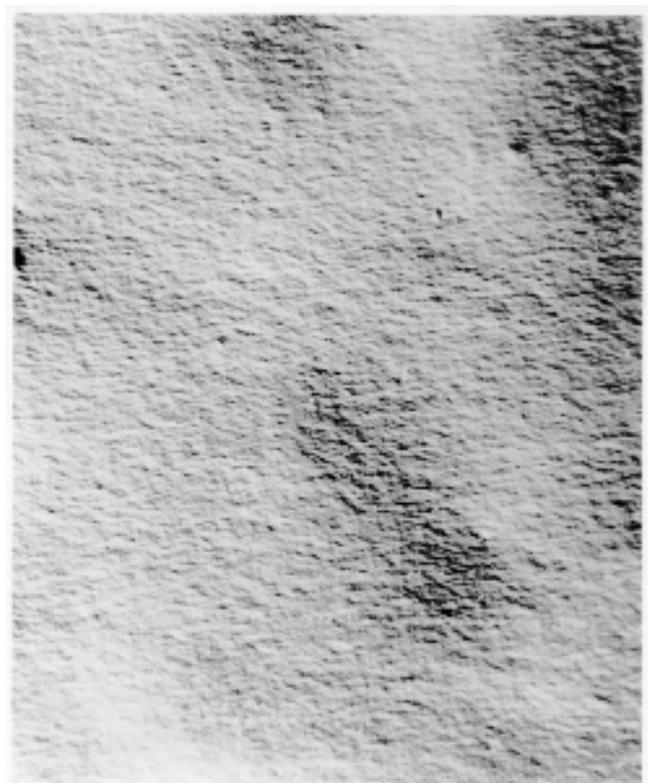
Figure 6: Magnification 100x 100 μm
Film Surface "B" - Metallized

We believe that this reflects a more consistent surface of "B" which in turn allows a more uniform aluminum deposition and better barrier.
